Assessment of visitor impacts on coastal bluff erosion at Point Lobos State Natural Reserve

January 2016

California State University Monterey Bay
California State Park
And
The Point Lobos Foundation

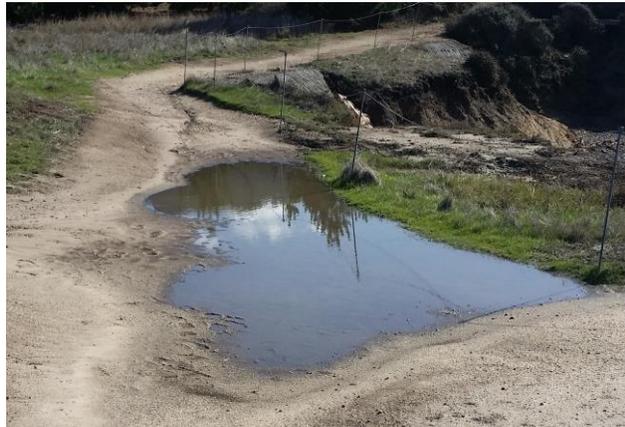
A significant aspect of trail degradation that was not considered in design of this project is water ponding in trails and trail ruggedness. Ponding in trails after a rain event force users to the edges of trails, where they inadvertently trample vegetation (Fig 15). Likewise, hikers will favor the vegetated trail edges if the main trail is too rugged from exposed roots and rocks. This active avoidance of official trails can lead to widening and the development of UCT's.

Figure 15: Trail ponding after rain event.

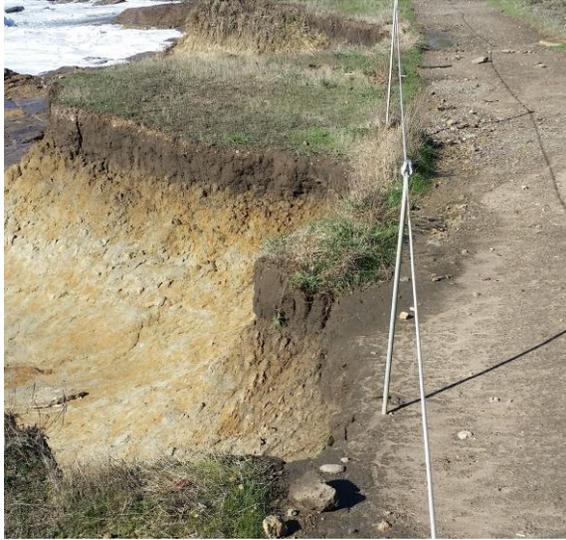
The trail around Weston beach is being encroached upon by a number of knickpoints which threaten the trail and can become a safety hazard (Fig 20). There is not enough room between the road and the bluff for a trail and an effective vegetated buffer. One solution would be to reduce the road down to one lane through this area (Appendix A, Fig. 21). The existing trail should be replanted to help reduce the erosion of the bluff to a more natural pace. If access to the beach is to continue, we suggest that clear access trails be provided with signs educating visitors on proper behavior at Weston Beach. Currently, there is a dense network of UCT's on the South end of Weston Beach that extend out onto

Figure 20: Knickpoint along Weston Beach.

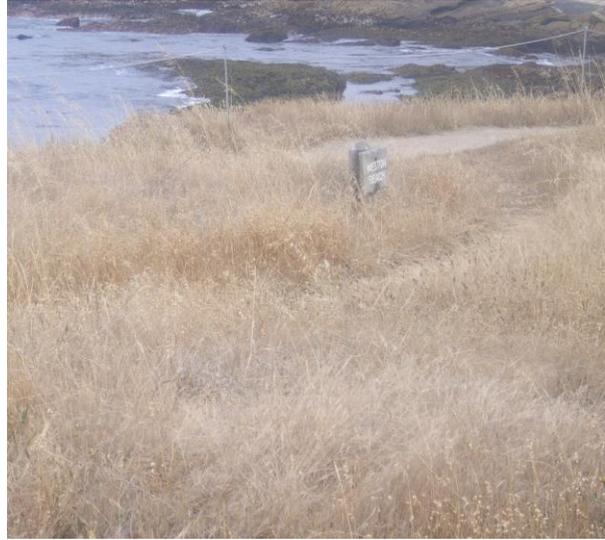
Figure 22: Sign reading “Weston Beach” oriented so that visitors must walk off the official trail in order to read it.

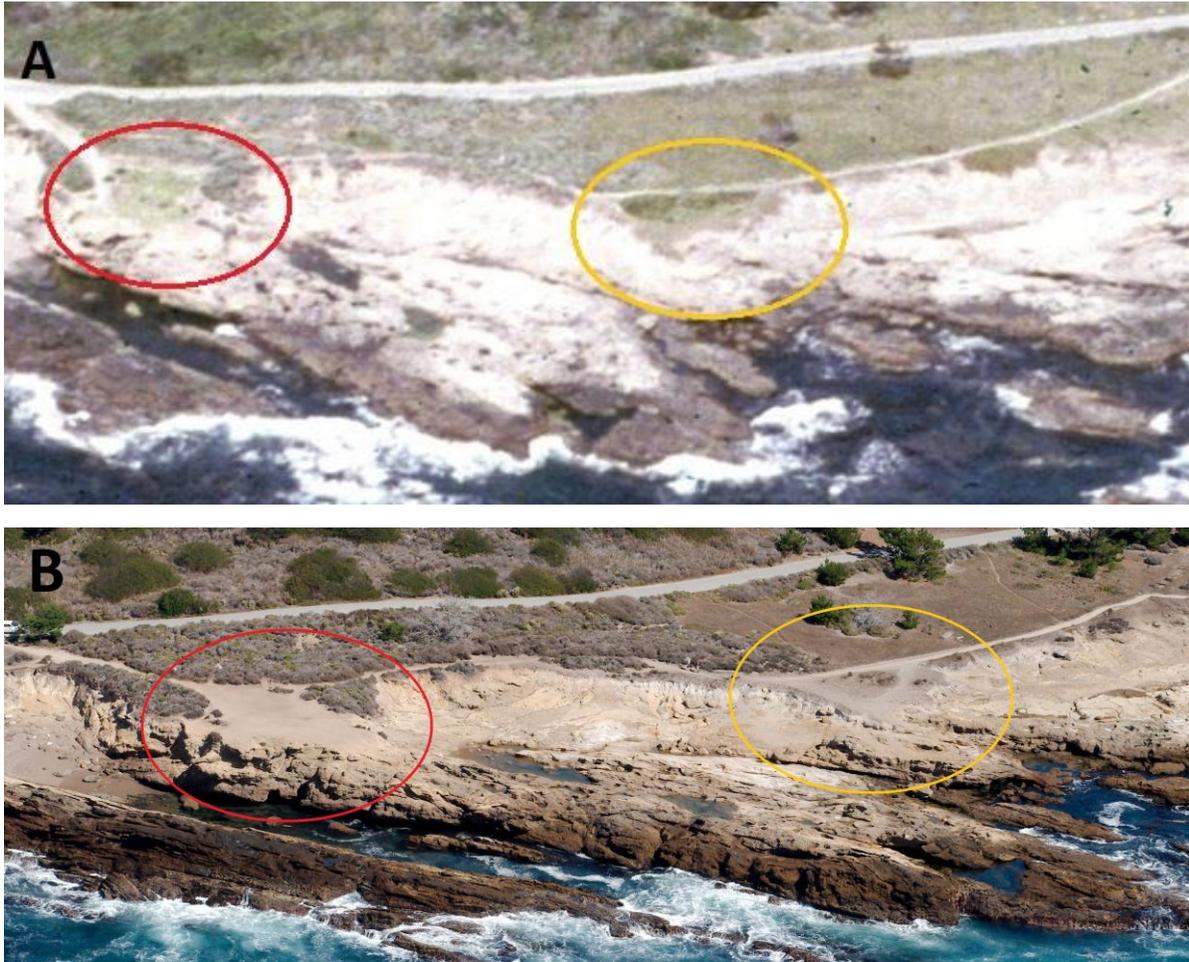
Figure 28: Comparison of bluffs from coastal photographs taken in 1979 (Picture A) and 2013 (picture B), showing the reduction in vegetation. These two bluffs pictured are located just south of The Slot, and were referred to as Slot 1 (red) and Slot 2 (yellow) in our surveys. (California Coastal Records Project <http://www.californiacoastline.org/>)

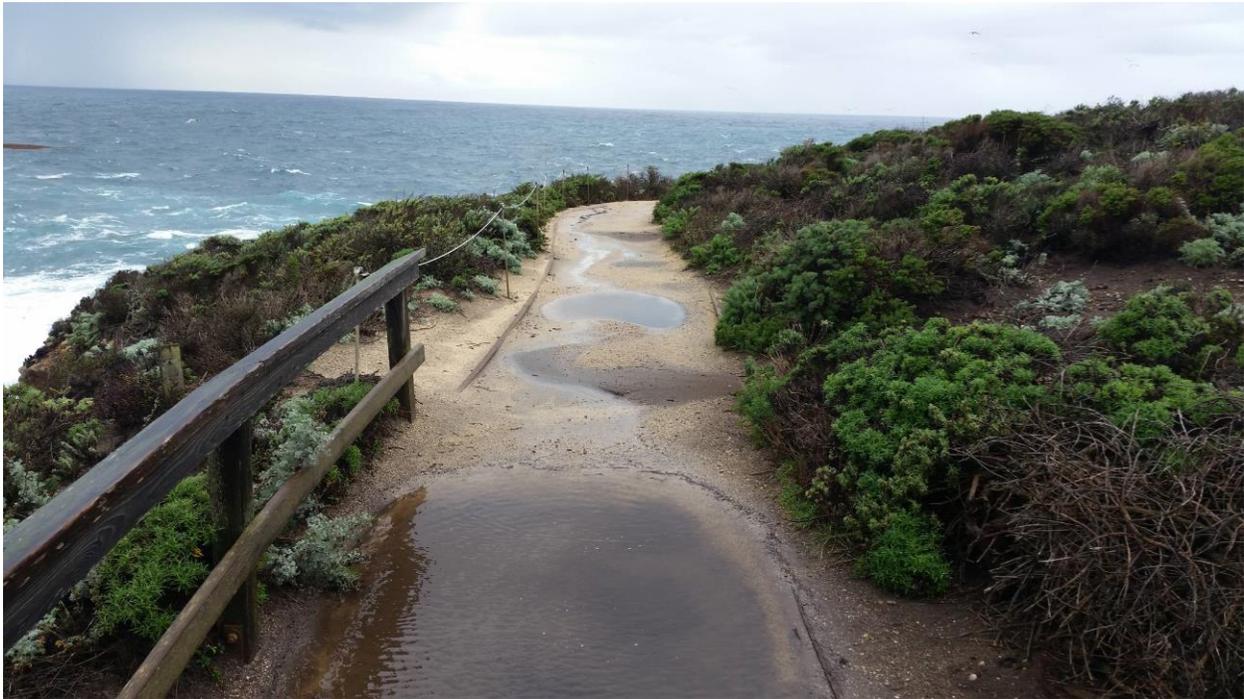
Figure 27: Ponding and running water on Sand Hill Cove Trail. Lack of water control features leads to sediment transport and trail degradation.

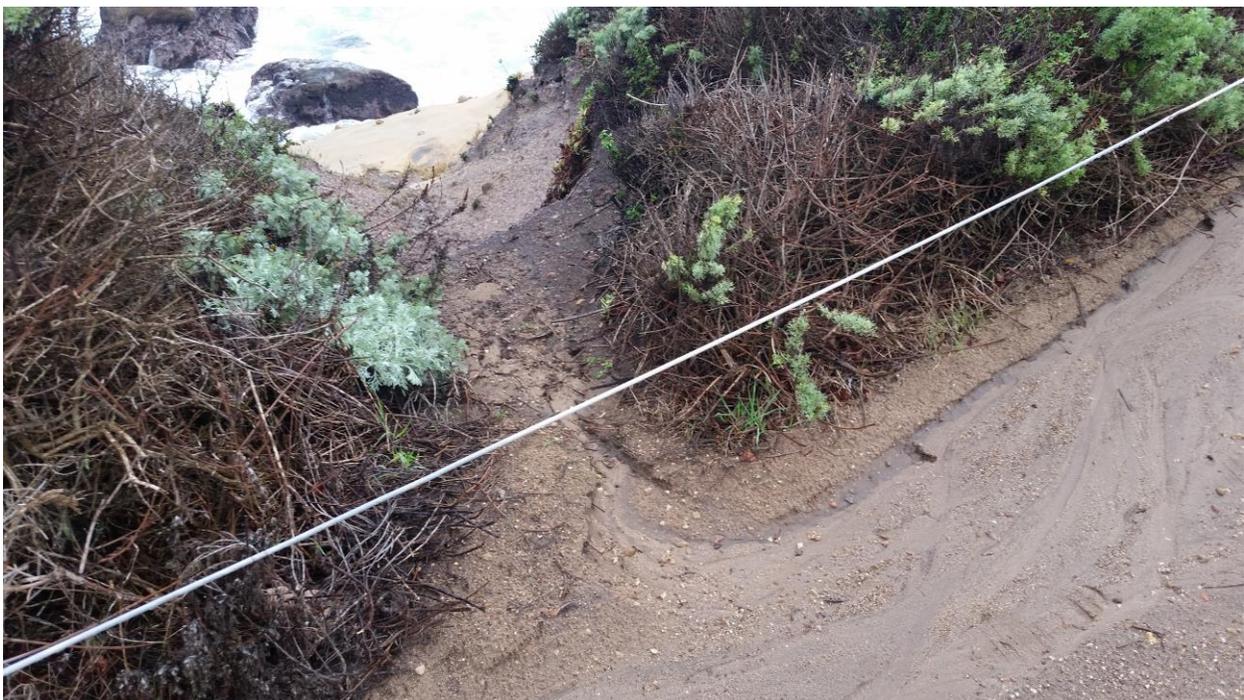
Figure 28: UCT off of trail by Sand Hill Cove allowing for sediment to discharge directly into ASBS.

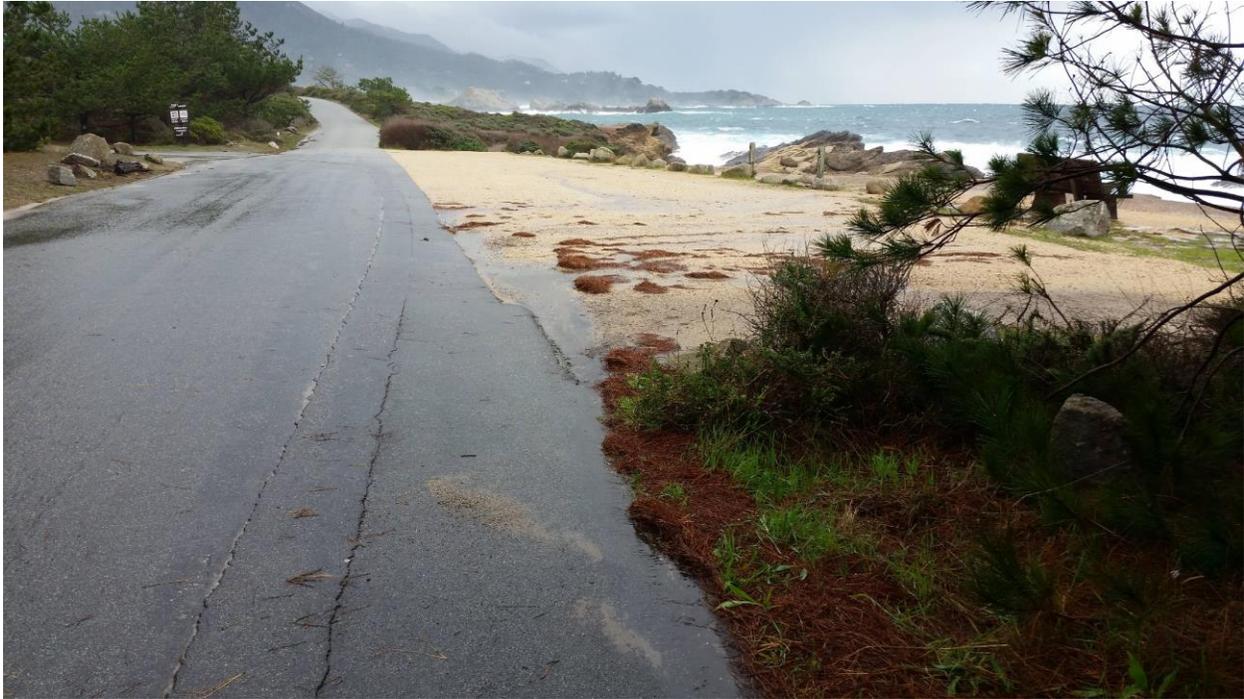
Figure 29: Water running down the road into the Piney Woods beach parking area. This increases the rate of bluff erosion by directing runoff onto the devegetated parking lot and bluff.

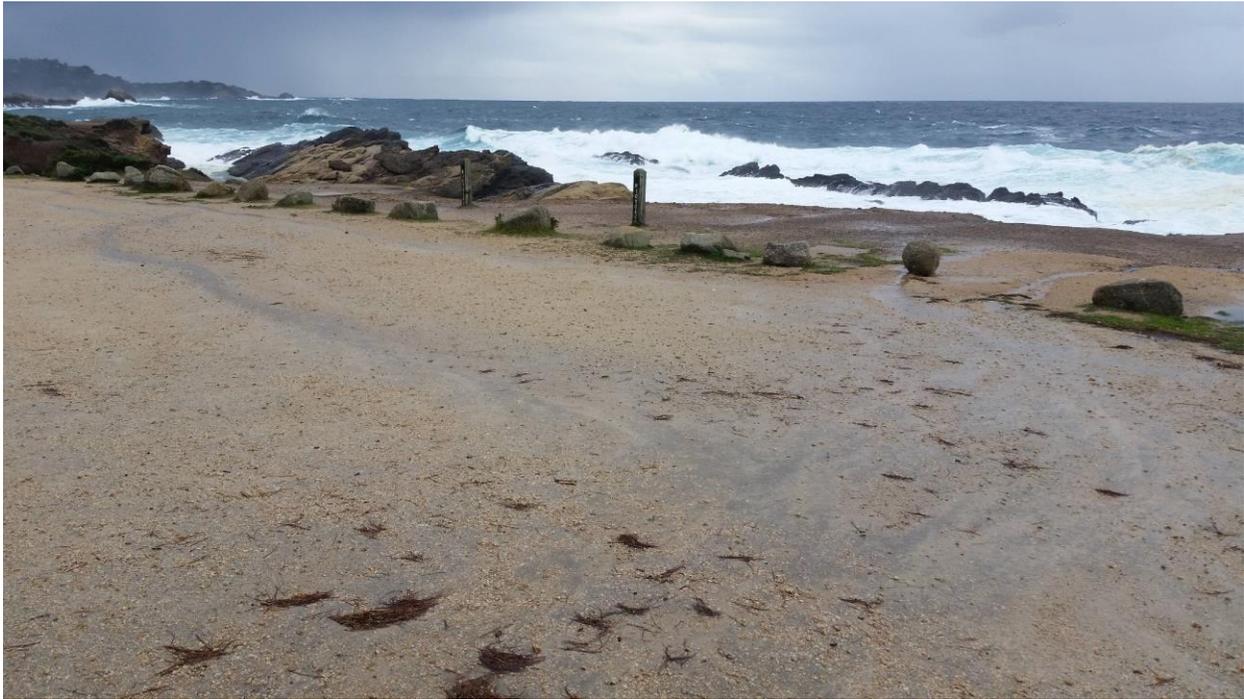
Figure 30: Sheet and rill flow across Piney Woods beach parking area to the adjacent devegetated bluff. The substrate from the parking area is being transported to the bluff and ocean.

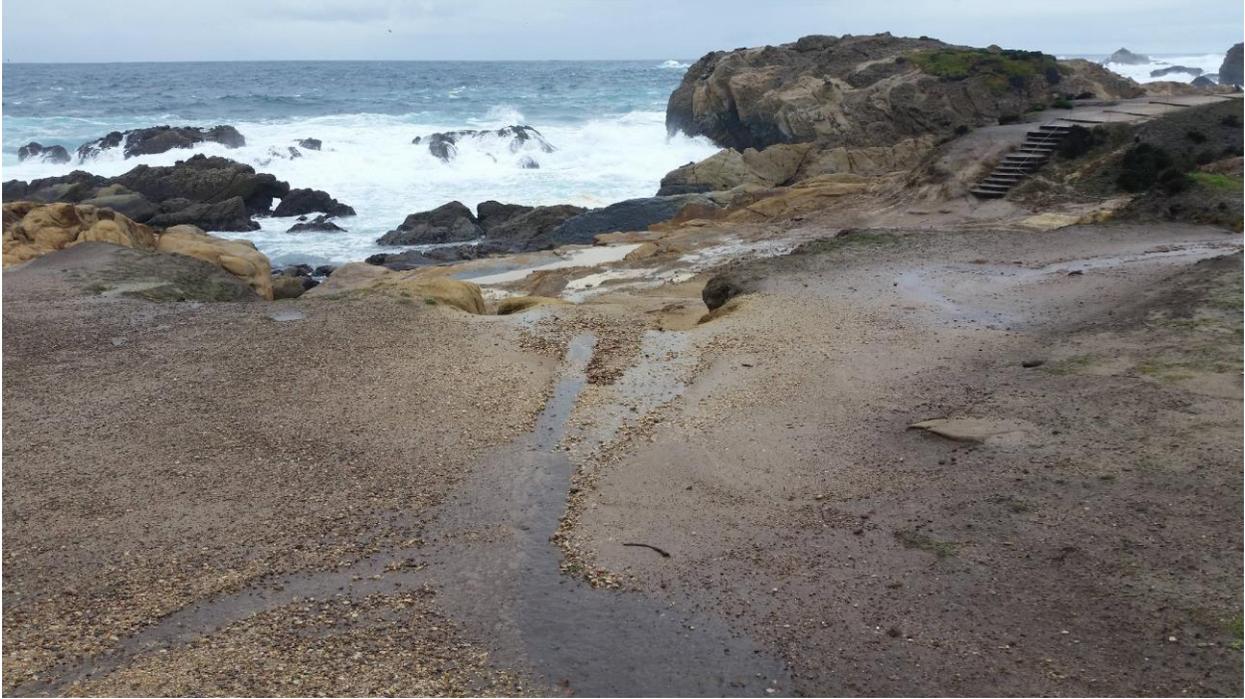
Figure 31: Unimpeded flow of water across the bluffs at the Piney Woods beach parking area to the ocean.

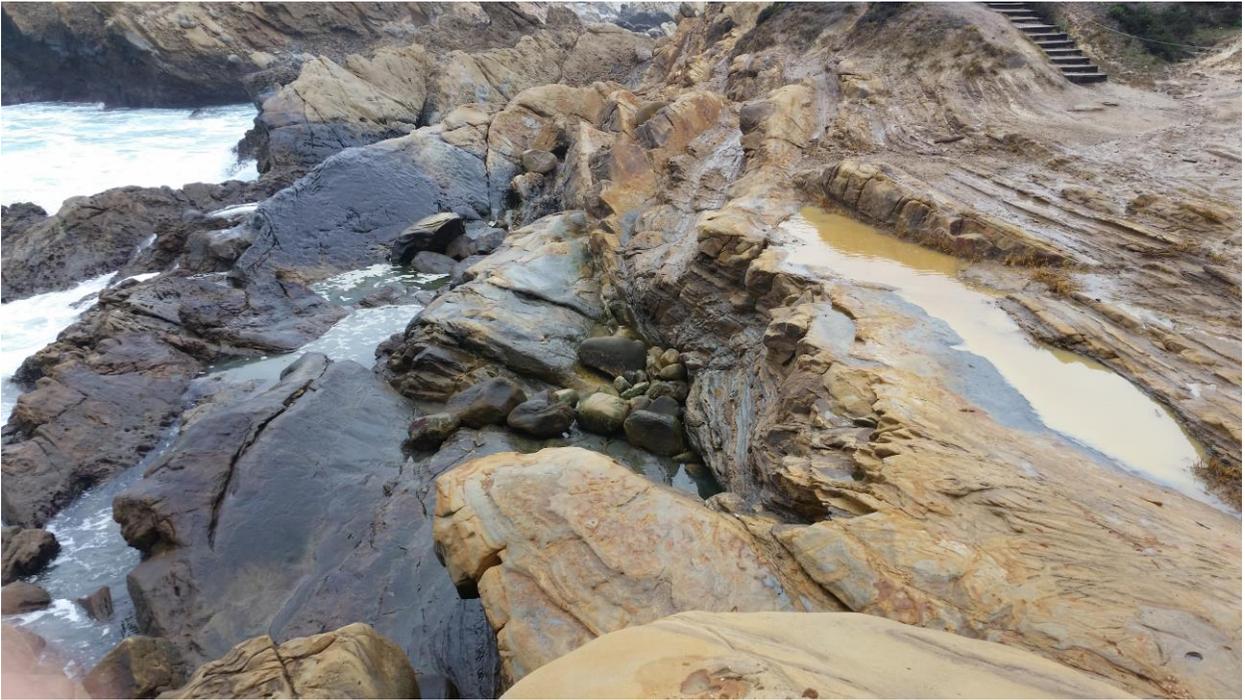
Figure 32: Sediment filled pools draining into ASBS.

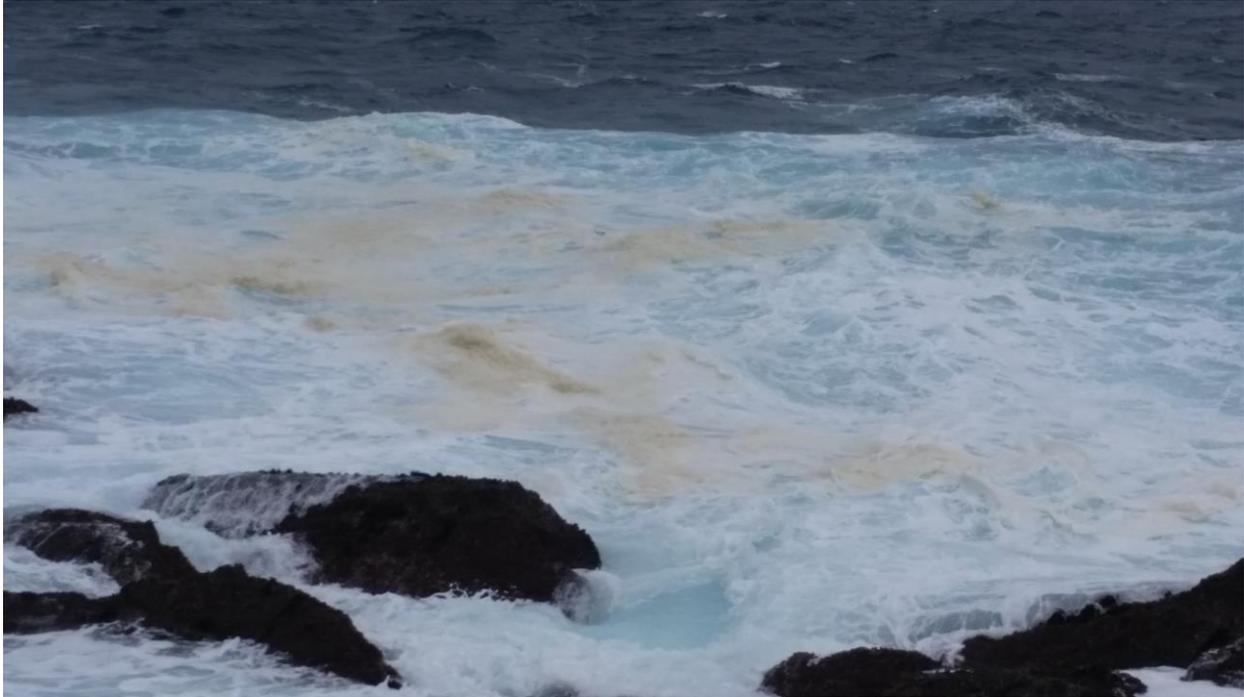
Figure 33: Sediment coloration to the foam in the surf adjacent to Piney Woods beach parking area.

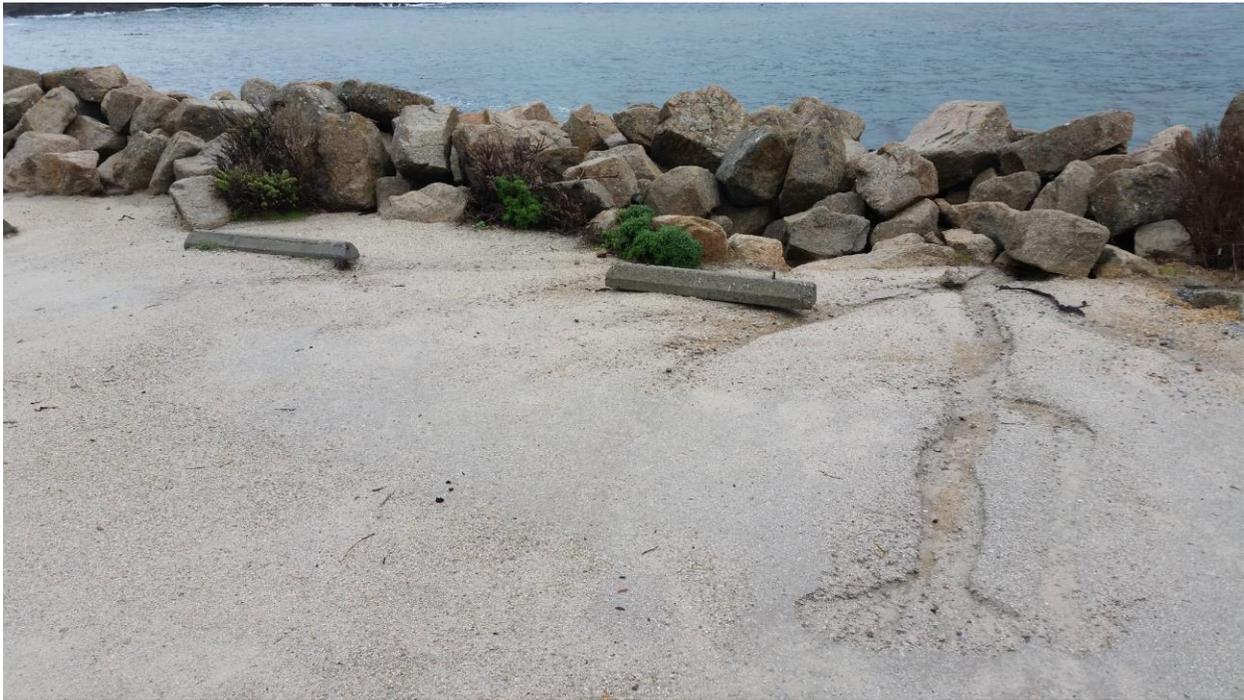
Figure 34: Erosion of the Whalers Point parking area into the ASBS.
